## Sandhurst Precinct – Draft LATM Plan

## Recommended Treatments

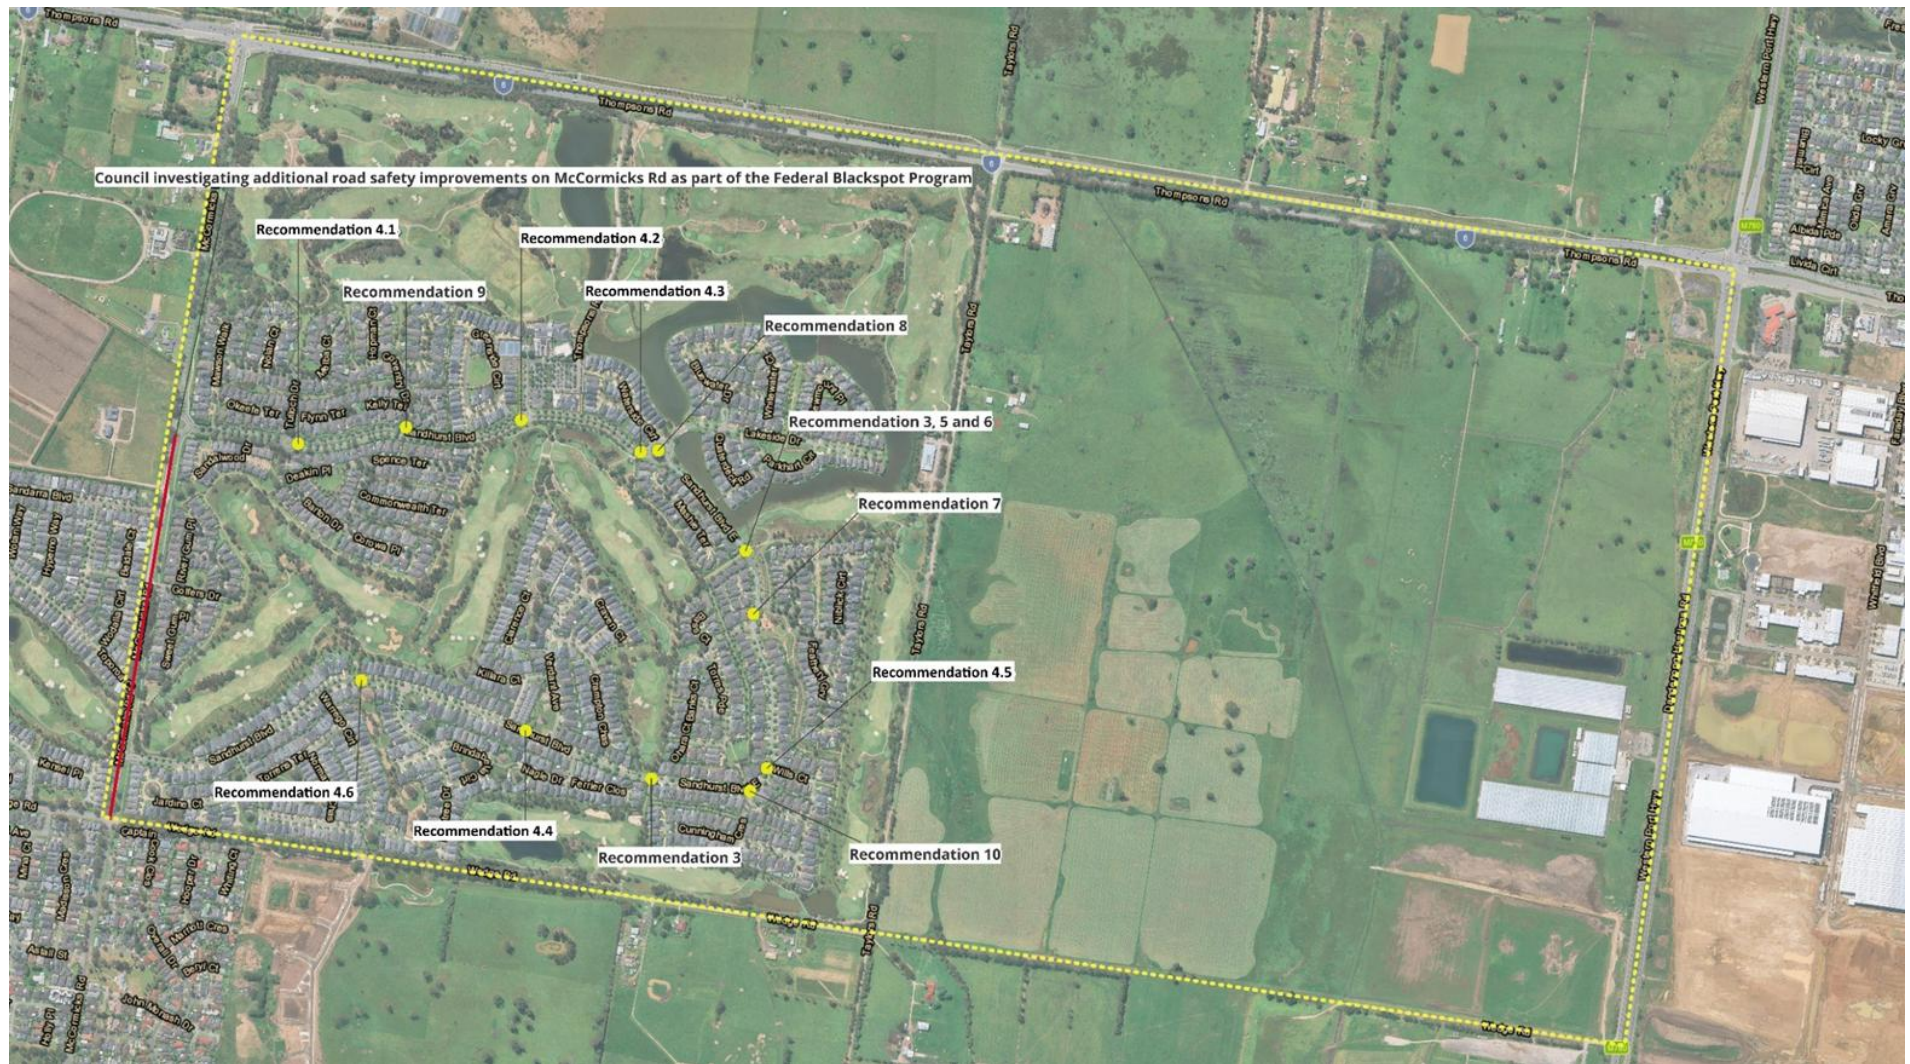
The proposed traffic management treatments to address the main traffic issues identified through community consultation, traffic speed and volume surveys, crash statistics and site investigations within Sandhurst Precinct are listed below, with those that have a specific location displayed on the above map.

| No. | Recommendation | Justification |
|---|---|---|
| 4 | Provide raised pedestrian crossings at: <ul style="list-style-type: none"> <li>— 4.1. in front of 2 Flynn Terrace</li> <li>— 4.2. west of Clubhouse Lane</li> <li>— 4.3. adjacent to 3 Waterside Circuit</li> <li>— 4.4. in front of 149 Sandhurst Boulevard</li> <li>— 4.5. in front of 104 Sandhurst Boulevard</li> <li>— 4.6. adjacent to 189 Sandhurst Boulevard</li> </ul> | Implementing raised pedestrian crossings at the existing crossings and at key locations will improve pedestrian connectivity within the study area and also help achieve speed control on Sandhurst Boulevard. |
